**MEMORANDUM OF AGREEMENT
AMONG
THE FEDERAL TRANSIT ADMINISTRATION,
THE DISTRICT OF COLUMBIA STATE HISTORIC PRESERVATION OFFICER
AND
THE WASHINGTON METROPOLITAN AREA TRANSIT AUTHORITY
REGARDING
THE NORTHERN BUS GARAGE RENOVATION PROJECT IN
WASHINGTON, DC**

WMATA NORTHERN BUS GARAGE: IDENTIFICATION OF HISTORIC FABRIC REPORT

Informing the Treatment of the Existing Structure and
Design of the Replacement Bus Garage

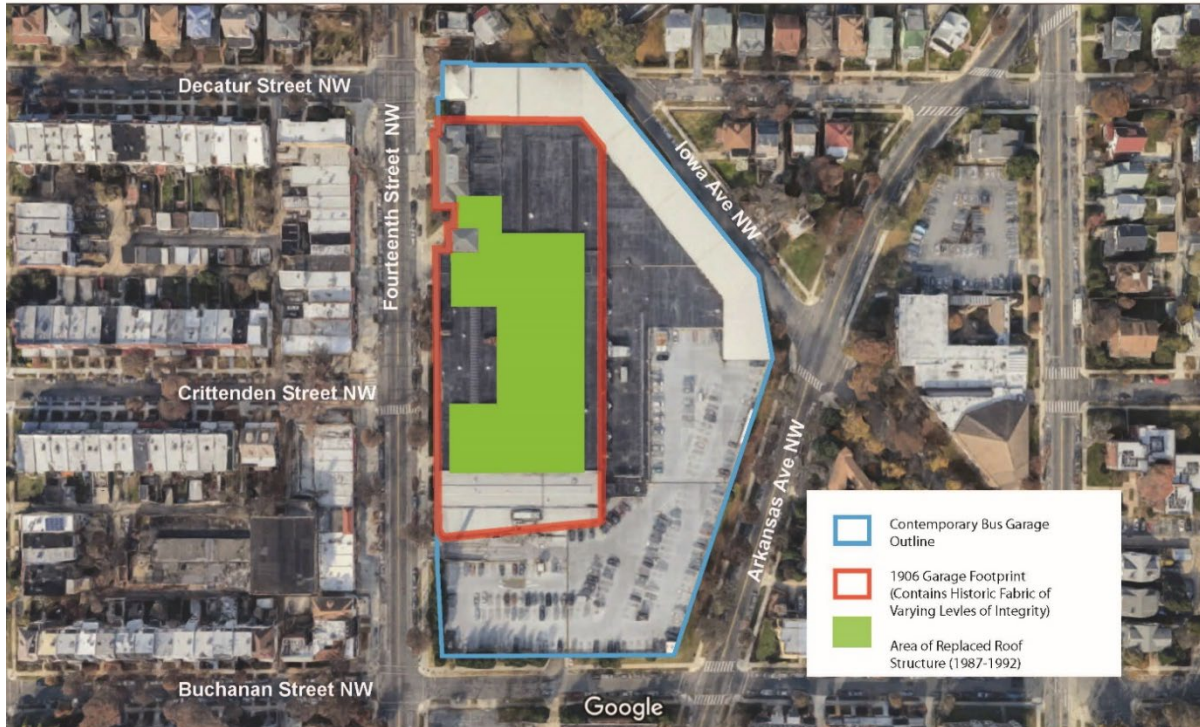
Figure 11. Diagram showing the extent of the original roof structure that was removed during the 1987-1992 renovation in green. The red outline shows the original footprint of the garage and the blue outline shows the contemporary property outline. Everything outside the red outline was added during the 1987-1992 renovation (BBB)

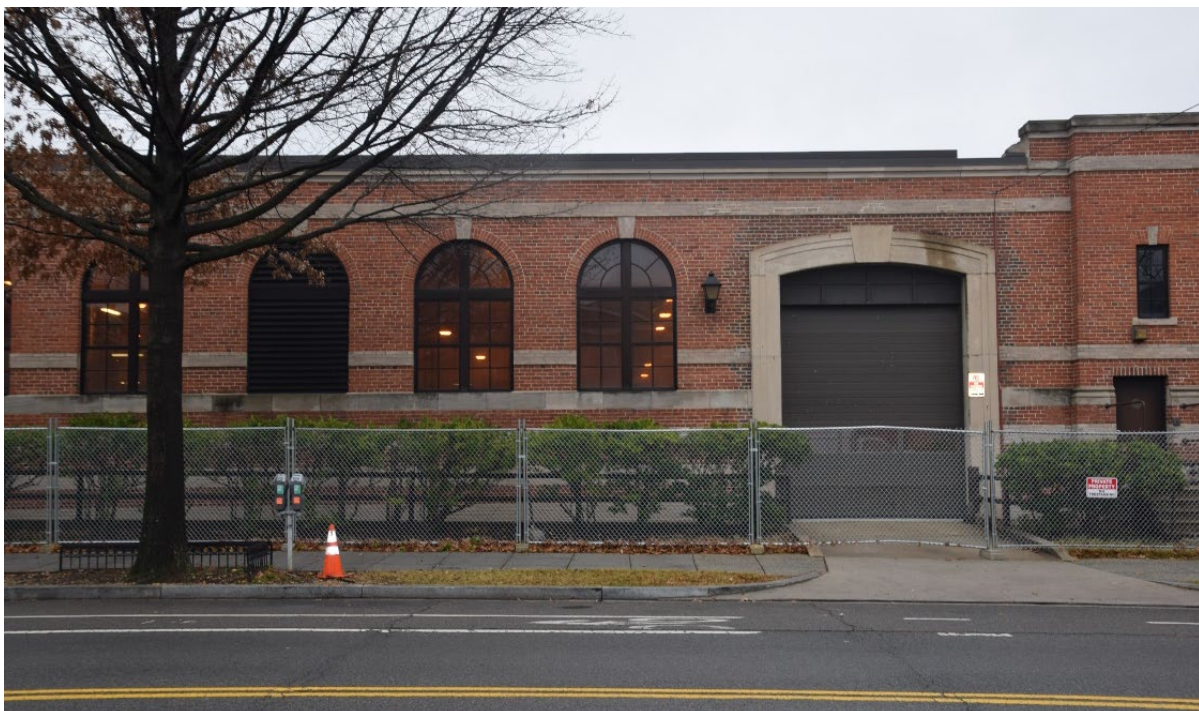
Figure 12. Bus entry at the southern end of the west façade was added during the 1987-1992 renovation (BBB)

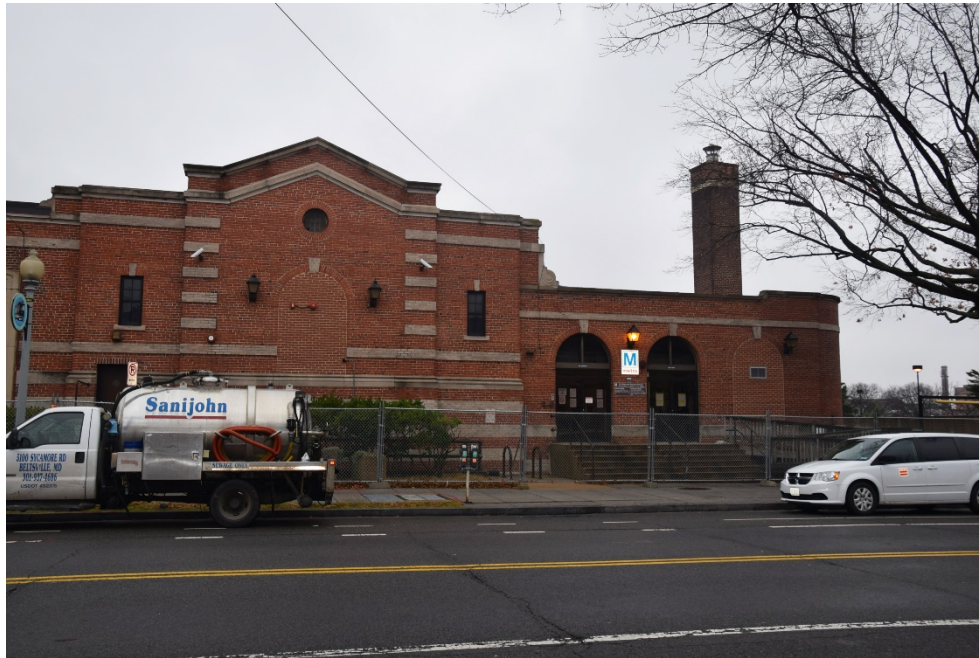
Figure 13. The two doorways to the right of the pedimented bay are not historic. The one on the left was changed from a window opening to a door prior to 1974 while the one on the right was changed during the 1987-1992 renovation (BBB)

From 1987 to 1992, the bus garage underwent a phased renovation and addition. The 1926 bus garage addition to the east of the original structure was demolished, and a one-story maintenance facility and garage with rooftop parking was constructed within the 1983 property wall, wrapping the east, south, and north elevations of the building. (See **Figure 9**) The majority of the original roof was demolished and rebuilt except for roofing over several bays at the northern end and a bay that remained along the full perimeter of the building. (See **Figure 10** and **Figure 11**) All but two of the original wood windows were replaced with aluminum windows, and several window openings were enclosed or changed to bus openings. A bus entry was inserted at the southern end of the west façade, immediately left (north) of the pedimented parapet at that end. (See **Figure 12**) To the right (south) of the pediment, an additional window was changed to a doorway. (See **Figure 13**)

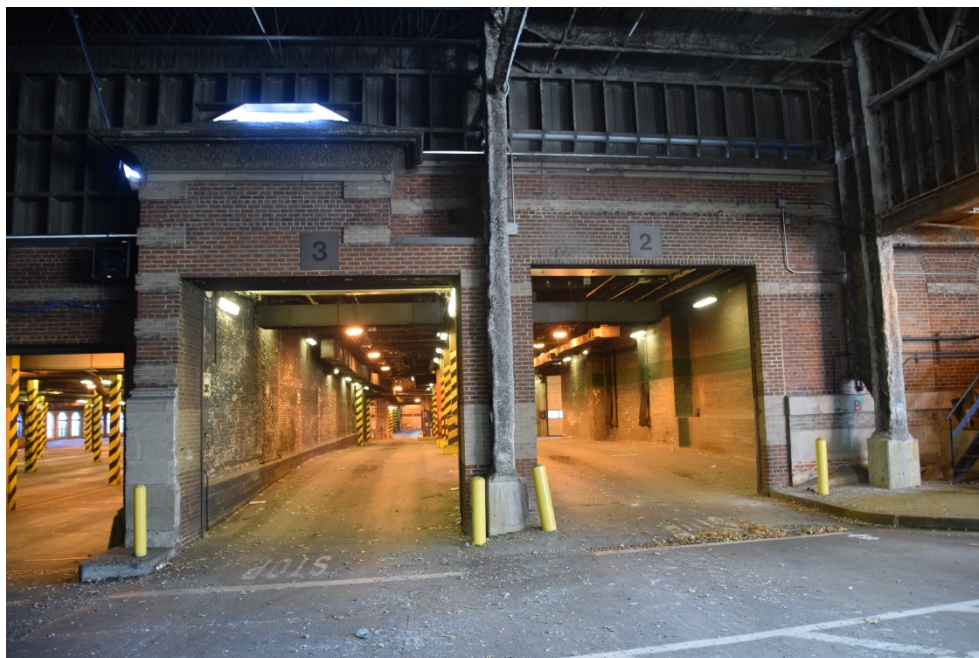
Figure 14. A truncated roof shelters the original north elevation and Decatur Street. Large openings for buses were punched in the wall during the 1987-1992 renovation (BBB)

The north and majority of the east elevations of the building were enclosed by the addition and bus ramp. The ramp descends west to east and north to south, following the topography of the site. As a result, Decatur Street, between 14th Street and Iowa Ave. was closed to traffic and was incorporated into the bus garage. A truncated roof encloses the original north elevation of garage. The original north elevation, which featured arched window openings was significantly altered with new bus openings, allowing buses to easily move from the garage to the bus ramp and exit at Decatur and 14th Streets. (See **Figure 14**) The east elevation was enveloped by the addition. The original arched window openings are

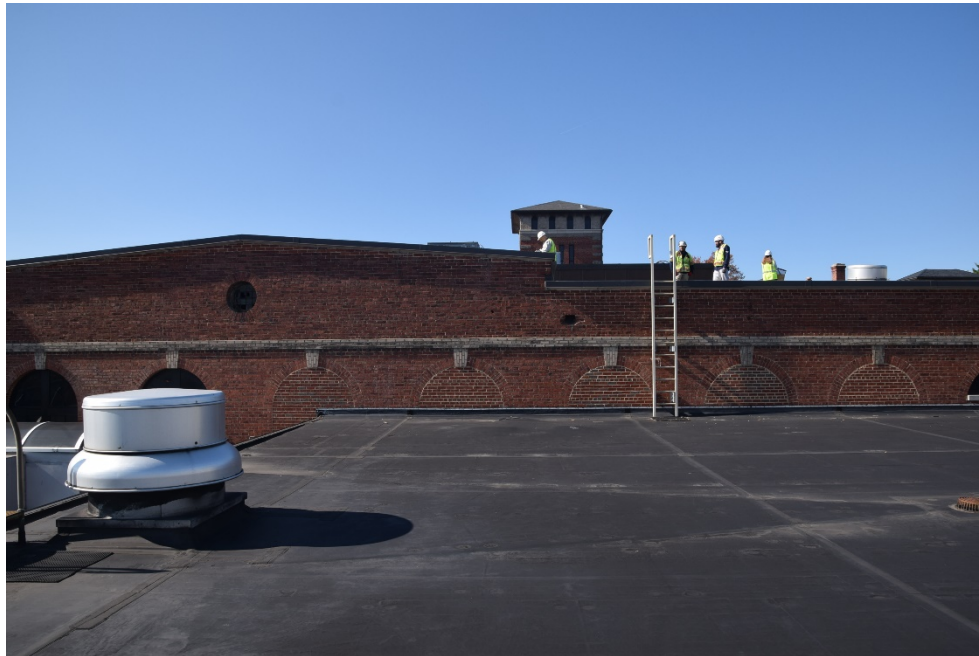
Figure 15. Roof of the 1987 addition abuts the original east elevation. Several of the arched windows have been infilled with brick (BBB)

still present, although many of the fanlights have been infilled with brick or replaced with louvers. The original east wall remains visible at the upper level interior and from the roof of the 1987 addition. (See **Figure 15**) The addition also had significant effects to the south elevation of the original structure. The lower level of the south elevation was fully enclosed and many of the windows at the upper level were removed and filled with glass block.

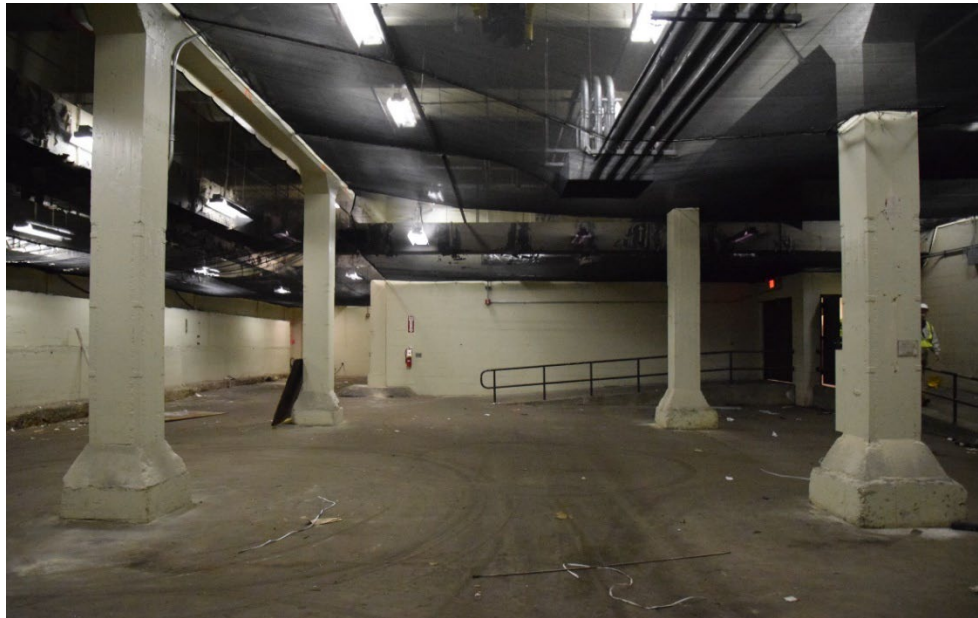
Figure 16. Lower level of the bus garage; the original columns and ceiling are present, however, the concrete floor was removed and excavated in the 1980s. The new concrete footings below the columns are visible in the photo (BBB)

Significant interior alterations were made to the administrative offices. Rooms were reconfigured, and a new stair and elevator tower addition was constructed at the north end of the office building. The stair and elevator tower was designed to match the Italian Renaissance Revival style of the rest of the building and features the same materials, a slate hipped roof, overhanging eaves with brackets, and similar brick detailing. The interior of the garage was also impacted. The majority of columns on the upper level were removed and reconstructed when the majority of the roof was demolished and rebuilt. On the lower level, the original columns and ceiling slab remain, however, the concrete floor slab was removed, and the floor was excavated approximately 12 inches and re-laid. The original columns and exterior walls are supported by non-historic concrete footings to adjust for the lowered floor. (See **Figure 16**)

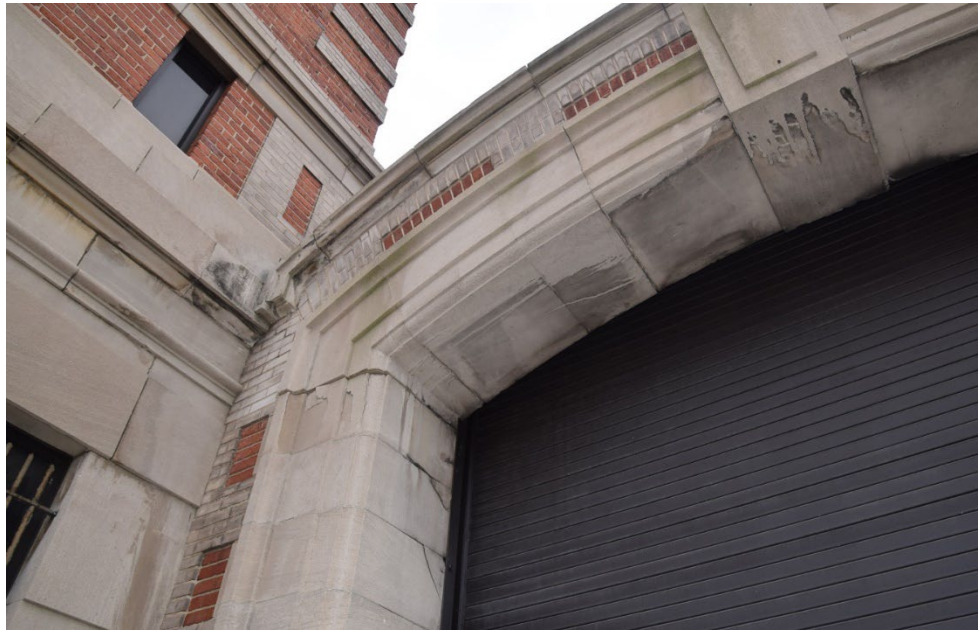
Figure 17. The north facing streetcar/bus opening adjacent to the tower exhibits stone cracking, spalling, and masonry soiling which require repair (BBB)

The administrative offices and 14th Street façade exterior building fabric are in overall fair condition. Open and debonded masonry joints are present but are concentrated to vertical facing joints at the building cornices, projecting string courses, and sills. The stone and brick masonry exhibit limited spalling, cracks, perforations from ferrous metal inserts or previous attachments, inappropriate past masonry repairs and patches, soiling, and biological growth. Cracks and spalling are especially present at the stone cornice and the stone surrounds at the original streetcar openings along 14th Street. (See **Figure 17**) The pebble-dashed stucco material present at the eaves of the administrative offices and tower is in good to fair condition, exhibiting some areas of cracking and missing stucco. Many slates on the hipped roof are broken or loose. Metal snow guards are bent and ineffective and the construction of the slate roof shows deficiencies. The roof should be investigated for appropriate flashing, slate headlap, underlayment, and ridge construction. The roof may require replacement.

Repair and restoration of the administrative offices and 14th Street NW masonry façade will require a variety of treatments. Cracks should be repaired and patched with grout or restoration mortar with a composition appropriate for the masonry substrate. Structural cracks may require the insertion of pins to further stabilize the masonry. Small spalls may be tooled to sound stone so that further spalling doesn't occur, and that water doesn't collect or pool. Larger spalls may require patching with restoration mortar or full or partial masonry replacement. All open and debonded joints should be repointed using matching mortar and missing masonry patched with matching materials. Ivy plants growing on the masonry should be carefully removed. The masonry should be cleaned using the gentlest means possible to remove soiling, staining, and biological growth. Soiling is especially apparent at the cornice and at the base of the building.

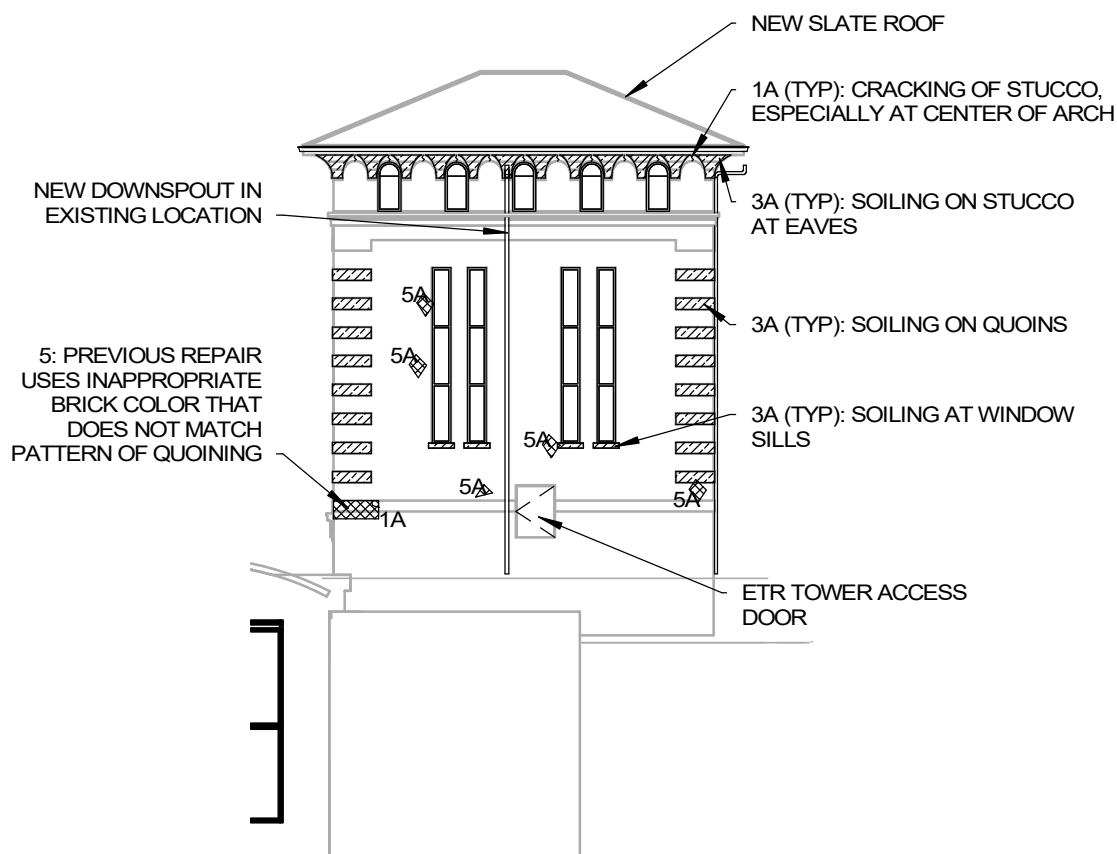
Northern Bus Garage - Preservation Treatment Approach - Elevations

2 EL-04-02 TOWER NORTH ELEVATION - EXTERIOR RESTORATION
ER102 1/16" = 1'-0"

4 EL-01-02 TOWER SOUTH ELEVATION - EXTERIOR RESTORATION
ER102 1/16" = 1'-0"

SYMBOLS LEGEND			SHEET	NOTES
<div>—</div> EXISTING <div>—</div> NEW OR REINSTALLED SALVAGED HISTORIC FABRIC EXISTING CONDITIONS REQUIRING TREATMENT <div>⚡</div> 1 - REPAIR CRACKS AND DEFORMATION 1A - CRACK <div>▨</div> 2 - REPAIR DETACHMENT AND DISLOCATION 2A - CHIPPING <div>▩</div> 3 - CLEAN DISCOLORATION AND DEPOSITS 3A - SOILING <div>⦿</div> 4 - REMOVE BIOLOGICAL COLONIZATION	<div>▨</div> 5 - ALTERATIONS/PREVIOUS REPAIRS. REMOVE NON-ORIGINAL BRICK OR STONE & INSTALL SALVAGED HISTORIC BRICK OR NEW STONE TO MATCH EXISTING. 5A - FERROUS METAL INSERTS <div>—</div> 6 - OPEN JOINT <div>---</div> 7 - DEBONDED JOINT <div>⦿</div> 8 - INACCESSIBLE PORTION OF FACADE DUE TO EXISTING CONSTRUCTION. BBB TO SURVEY AFTER DEMOLITION REFER TO BRICK AND STONE REPAIR, REPOINTING AND CLEANING SPECIFICATIONS FOR TREATMENT PROCEDURES	<div>🏠</div> NEW ALUMINUM WRAPPED WOOD CORE WINDOW WITH IGU RE: ER-601 FOR WINDOW SCHEDULE <div>🏠</div> REINSTALLED RESTORED HISTORIC WOOD WINDOW RE: ER-601 FOR WINDOW SCHEDULE <div>ER-01</div> NEW DOOR TAG <div>FS01</div> WINDOW TAG	4	1. INSTALL NEW SLATE ROOF AND UNDERLAYMENT AT TOWER, ADMINISTRATION BUILDING, & HIPPED ROOF TO NORTH OF ADMINISTRATION BUILDING TO REMAIN. REFER TO ARCH DRAWINGS FOR SPLASH BLOCKS 2. ALL MASONRY TO RECEIVE GENERAL CLEANING. REFER TO MASONRY CLEANING SPECS 3. REMOVE ALL EXISTING PARAPET FLASHING . REPOINT ALL SKYWARD FACING JOINTS IN PARAPET & INSTALL LEAD T'S AT ALL HORIZONTAL JOINTS IN EXISTING LIMESTONE COPING

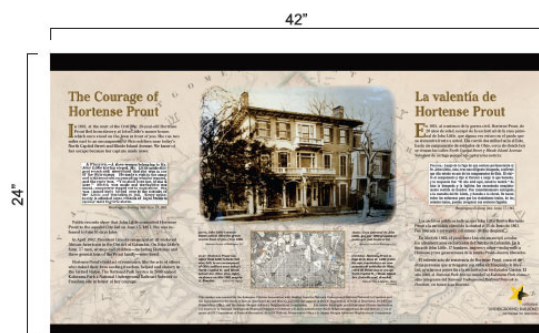
QTY: 1 (24"x42") EXTERIOR GRAPHIC FOR PEDESTAL

SCALE: 3/4"=1'-0"

MATERIAL: EXTERIOR GRADE CHPL GRAPHIC FOR
SURFACE MOUNT ON PEDESTAL
